# Performance of Strip Seals in Iowa Bridges, Pilot Study

FINAL REPORT

Iowa Highway Research Board  
Project TR-437

Iowa State University

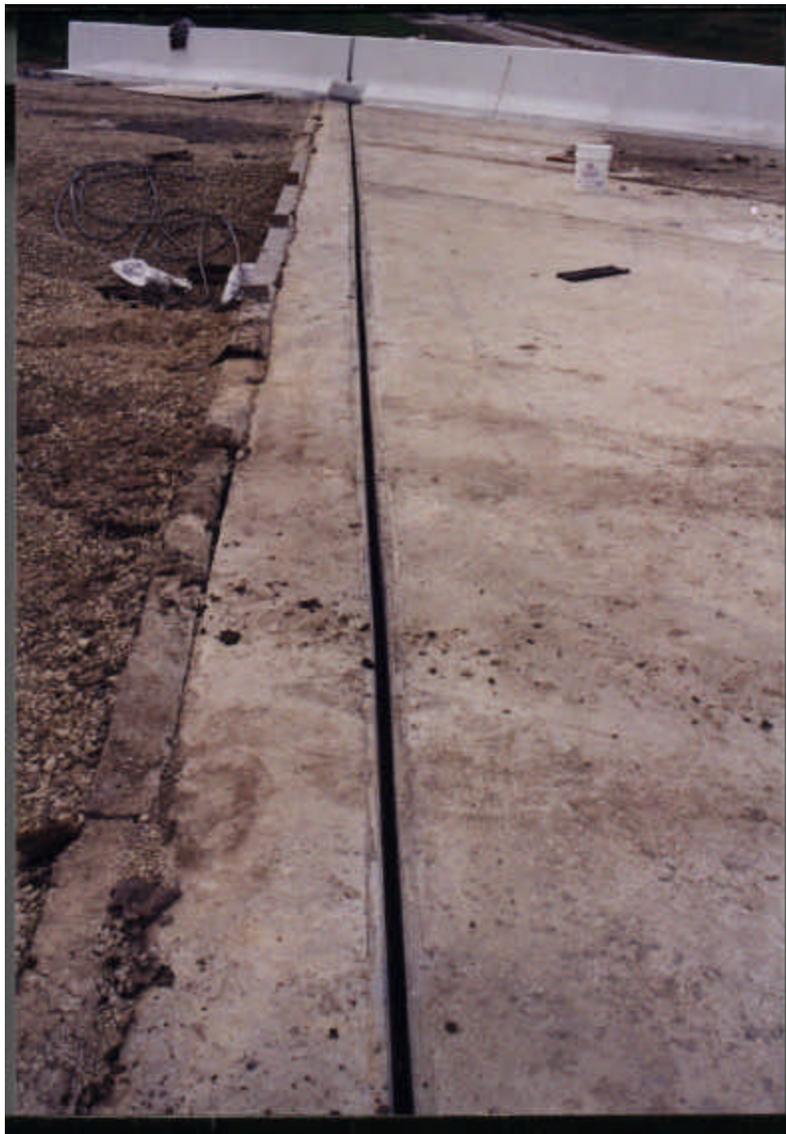
Figure 4.19 Installation of seal complete at east end

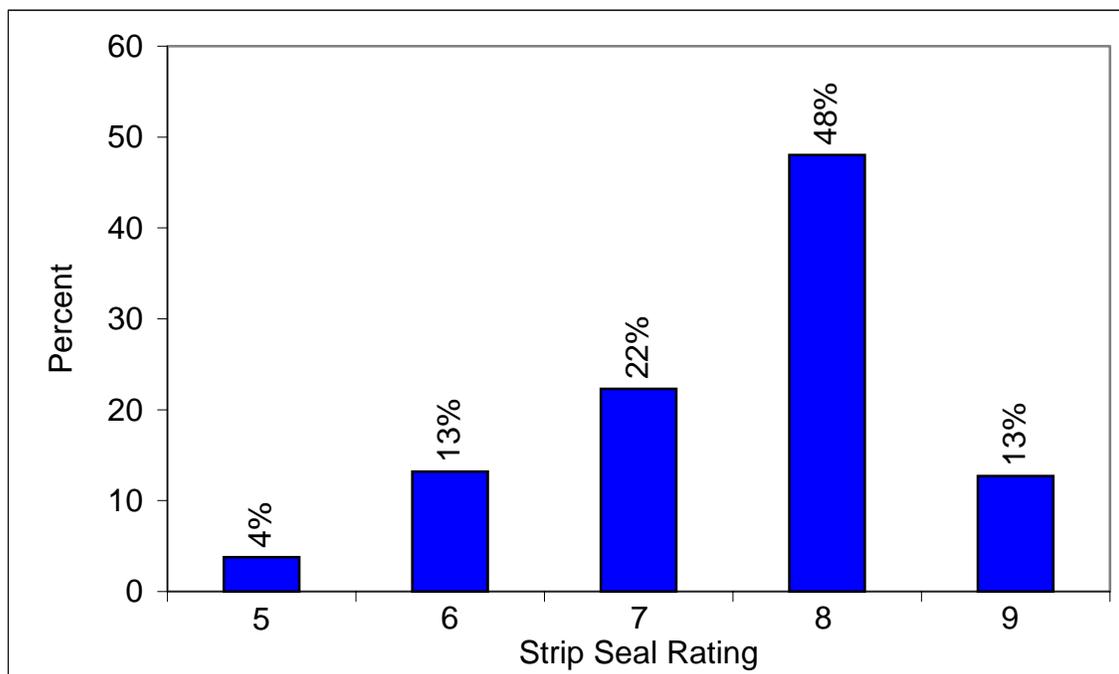
Figure 5.1 – Ratings of the end deck joint strip seals in Iowa bridges

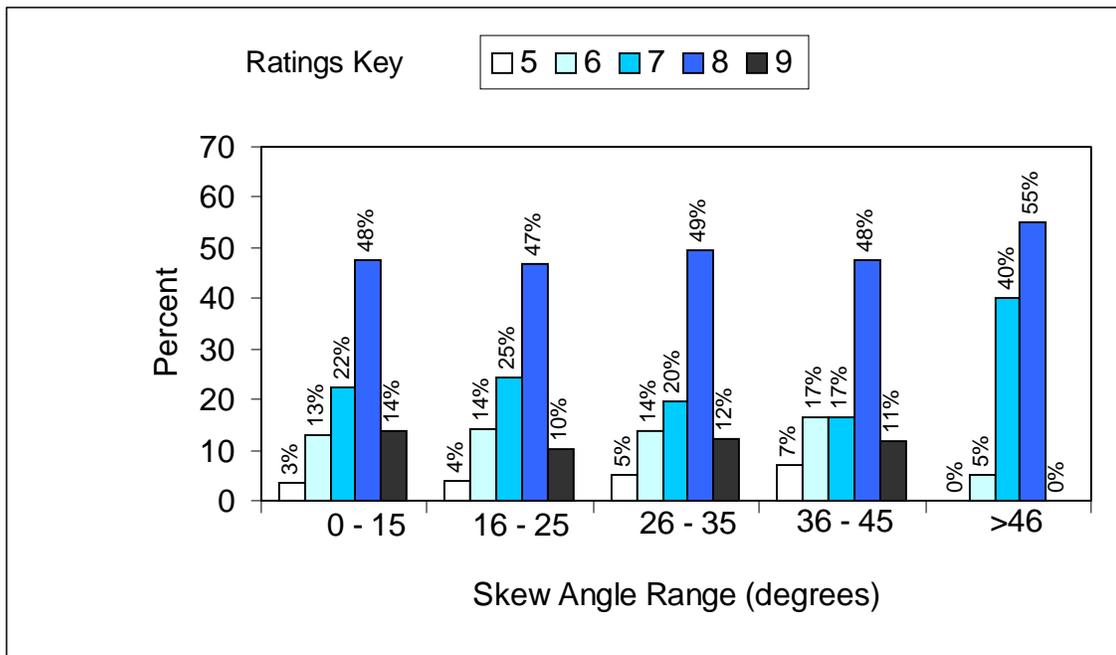
Figure 5.2 End deck joint strip seal rating versus skew angle of bridge

Figure 5.2 shows the distributions of ratings as a function of skew angle of the bridge deck. As shown in Figure 5.2, the combined percentage of strip-seal expansion joints with a rating of 5 or 6 increases slightly as the range of the skew angle of the bridge deck increases from 0°-15° to 35°-45°, but the evidence is not sufficient to draw any firm conclusion.

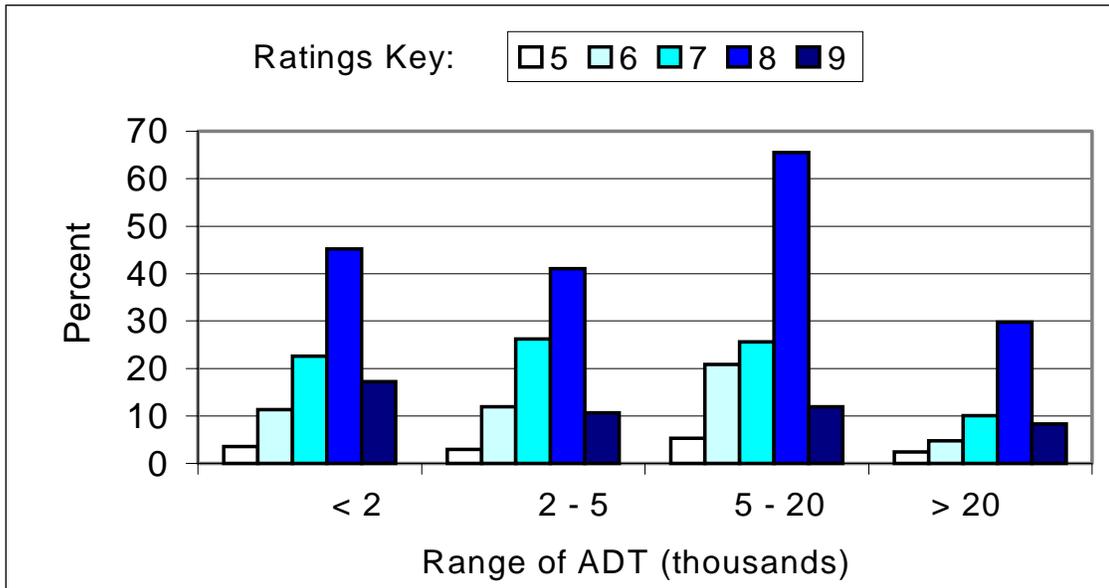
Figure 5.3 End deck joint strip-seal rating versus Average Daily Traffic (ADT)

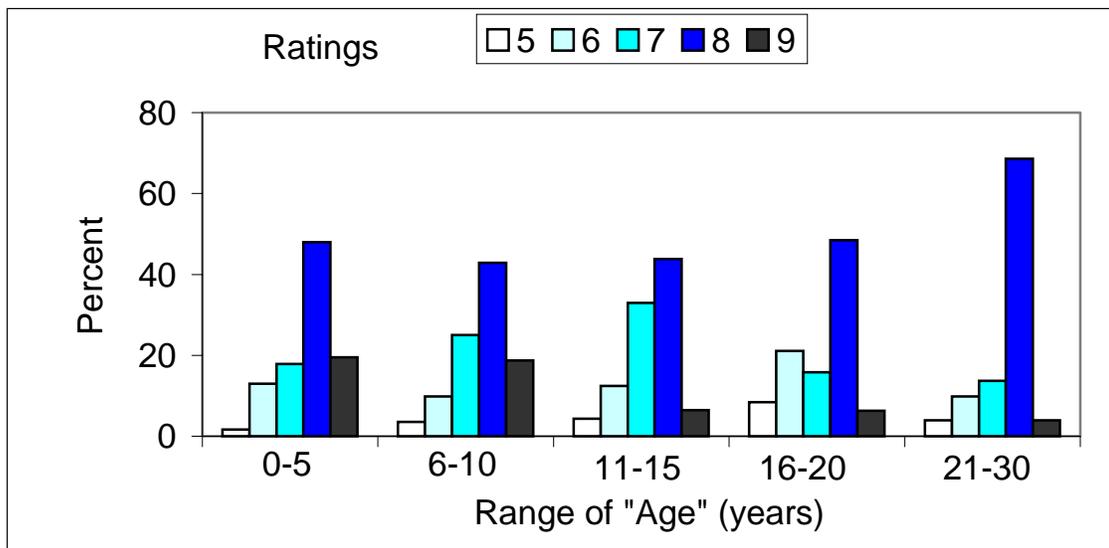
Figure 5.4 End deck joint strip-seal rating versus "age" of seal

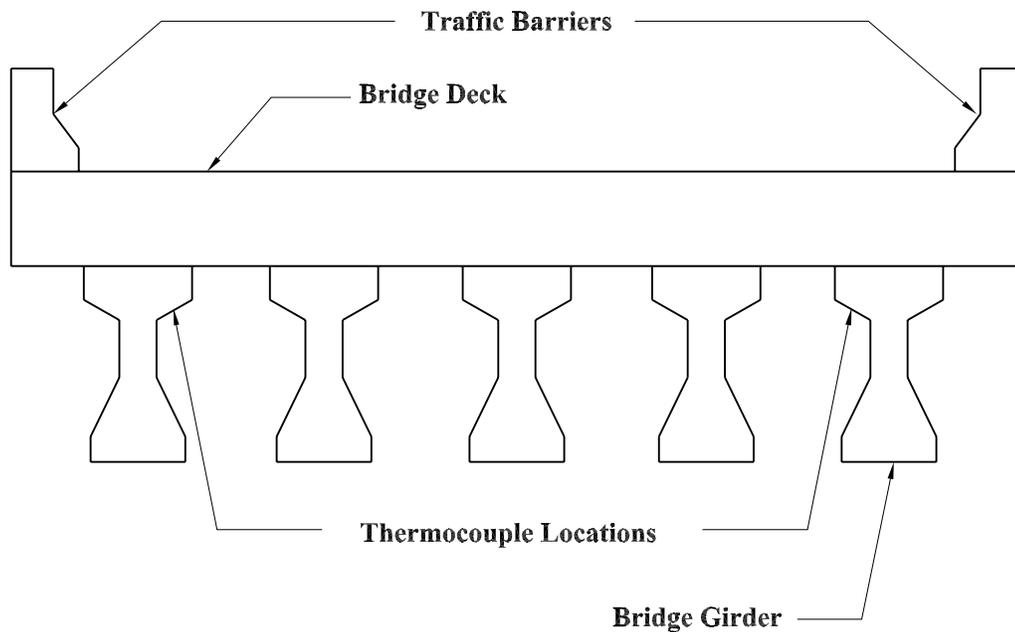
(b) Cross-sectional view (not to scale)

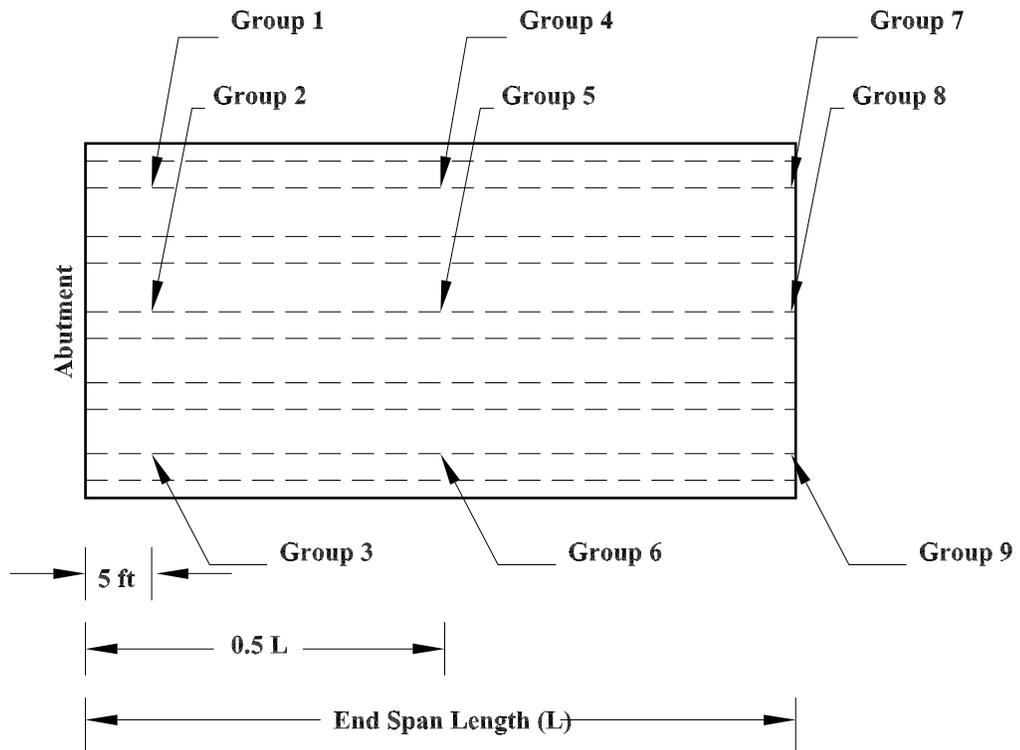
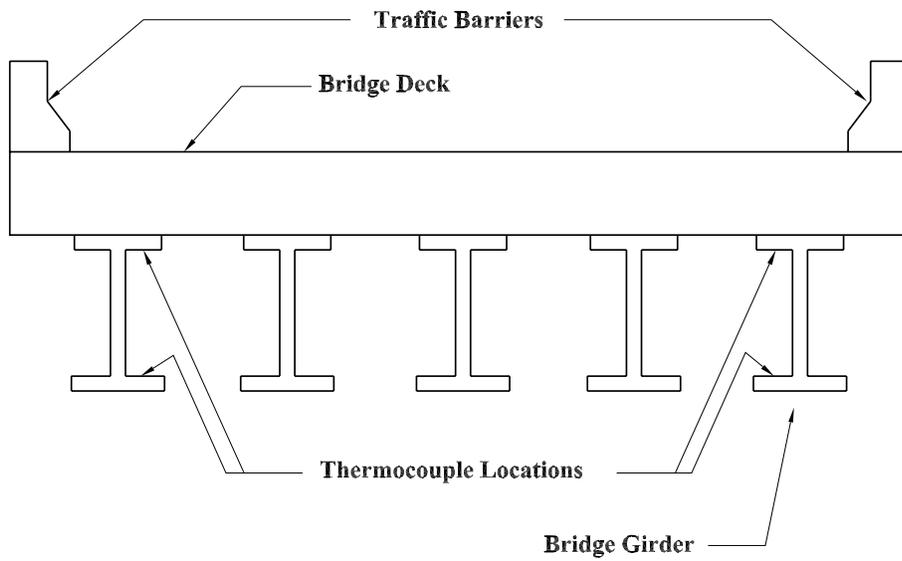
(a) Plan view (not to scale)

(b) Cross-sectional view (not to scale)

The integral abutment bridge studies did not provide information about the best location for determining  $T_b$  for steel-girder bridges. Therefore, one of the steel-girder bridges in this study (Bridge 9, Maintenance Number 6485.3L030) was instrumented with twenty thermocouples. Eighteen of the thermocouples were installed on the girders in nine groups in one of the end spans as shown in Figure 6.2 and two were installed in the deck

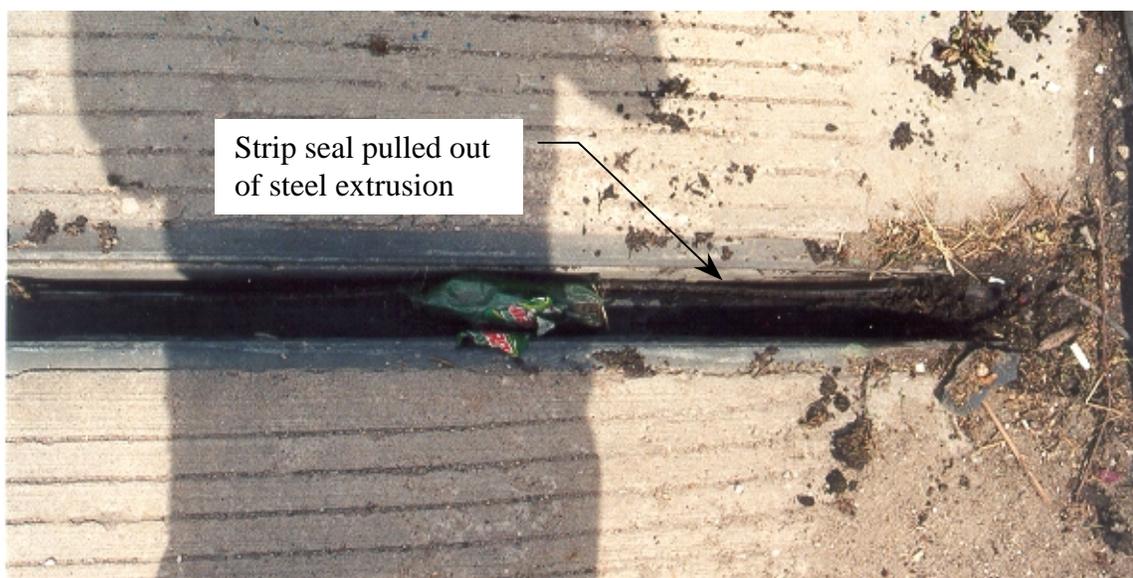
Figure 6.4 Strip seal at G2 for Bridge 1 (0781.1R218)

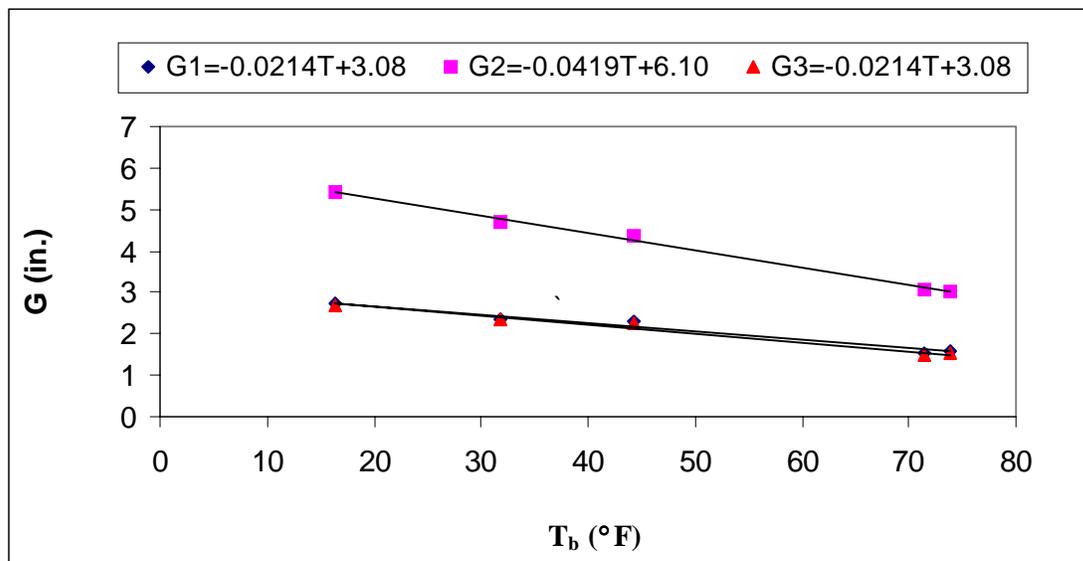
Figure 6.5 Gap openings vs. bridge temperature for Bridge 1 (0781.1R218)

on the chart and are also given in equation form at the top of Figure 6.5. Though no temperatures very near 0° F were recorded during this investigation, the linear plots are extended back to 0° F as a dashed line to show the gaps that could be expected at the minimum temperatures assumed in the Iowa DOT design procedure for concrete-girder bridges (Section 3.3).

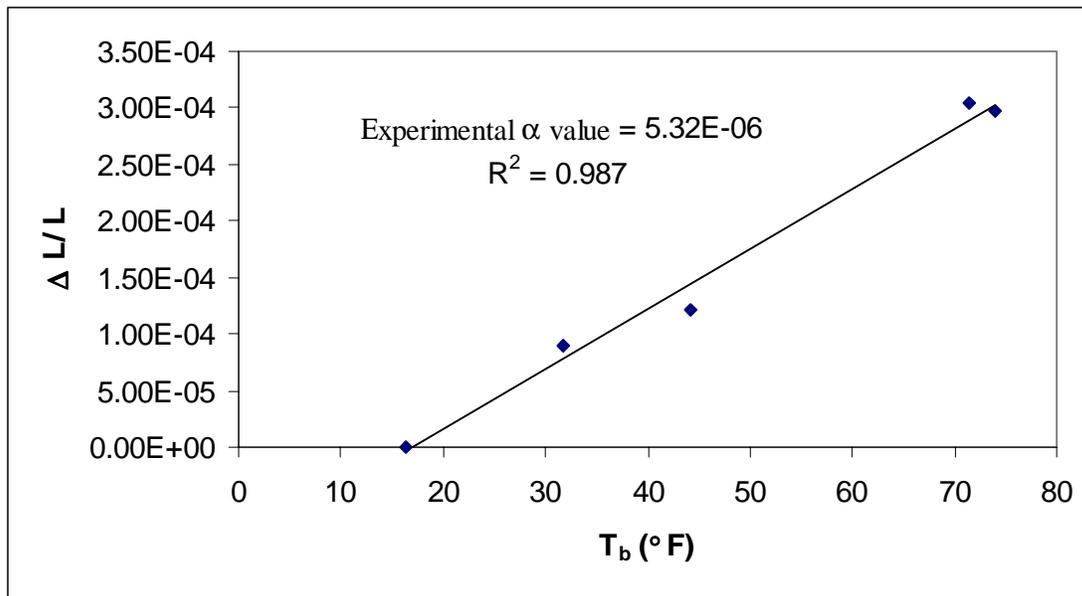
Figure 6.6 The experimental  $\alpha$ -value for Bridge 1 (0781.1R218)

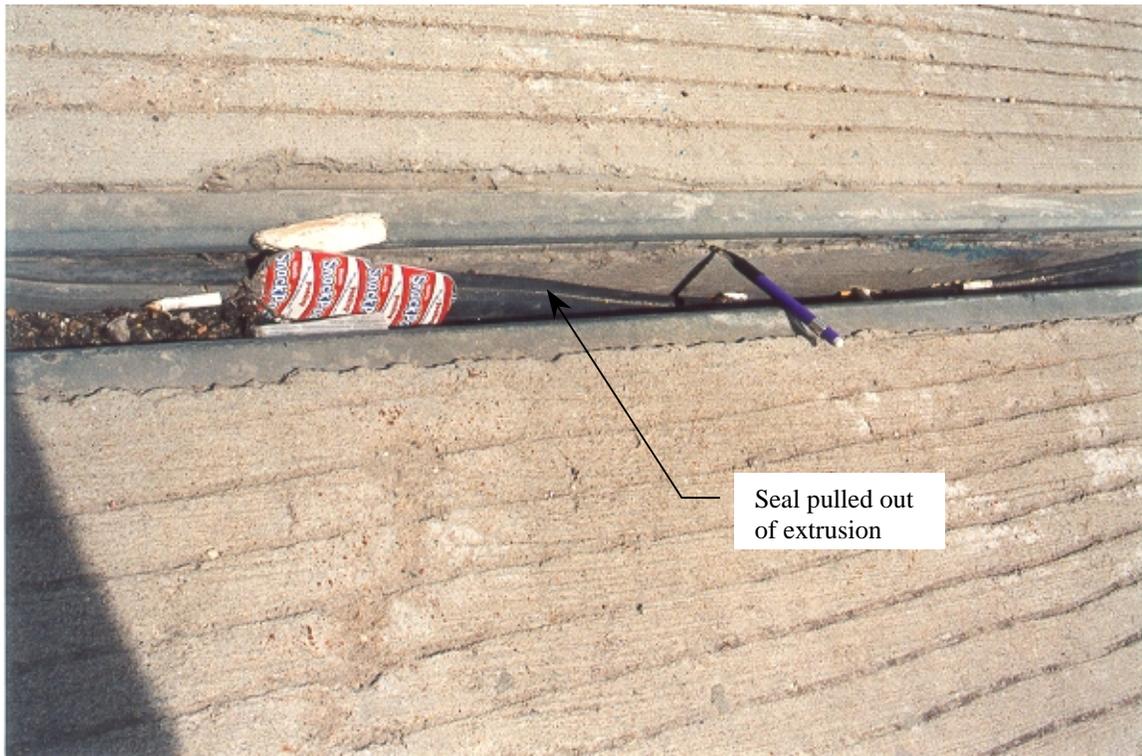
Figure 6.7 Strip seal at G2 for Bridge 2 (0781.1L218)

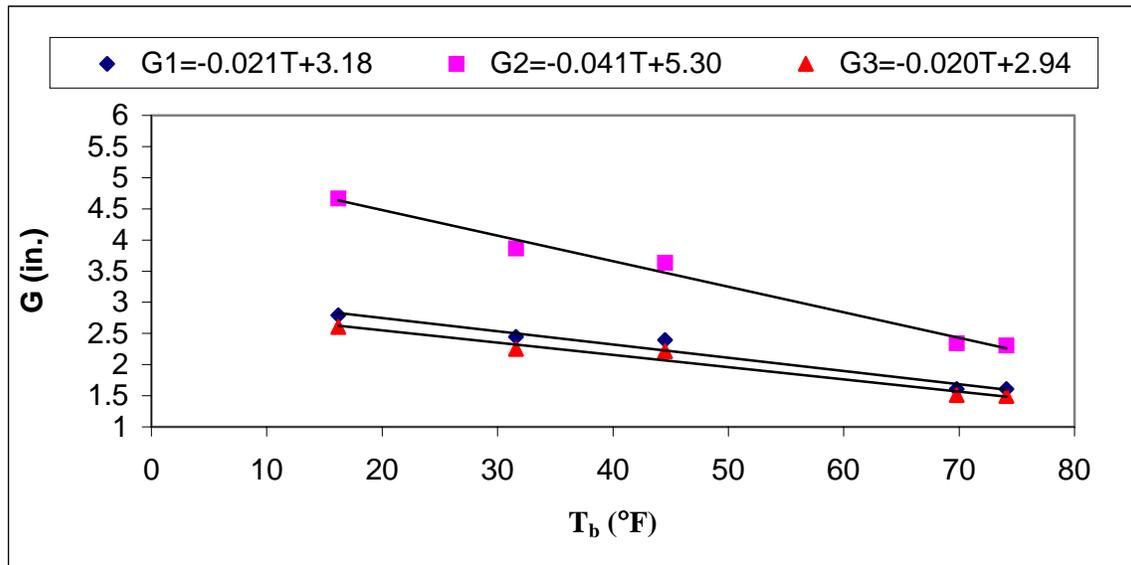
Figure 6.8 Gap openings vs. bridge temperature for Bridge 2 (0781.1L218)

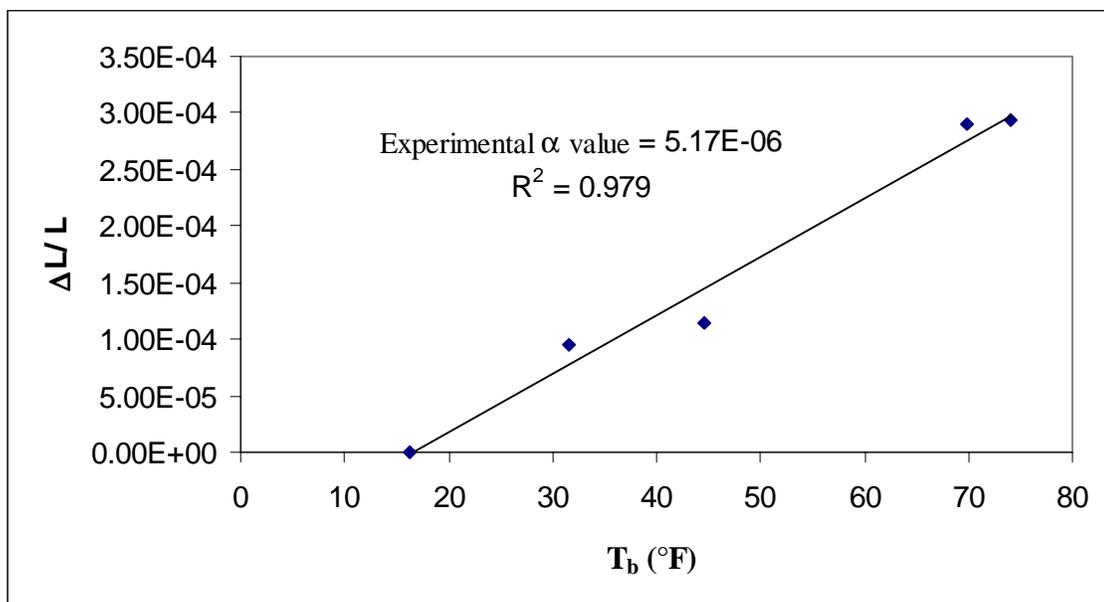
Figure 6.9 The experimental  $\alpha$ -value for Bridge 2 (0781.1L218)

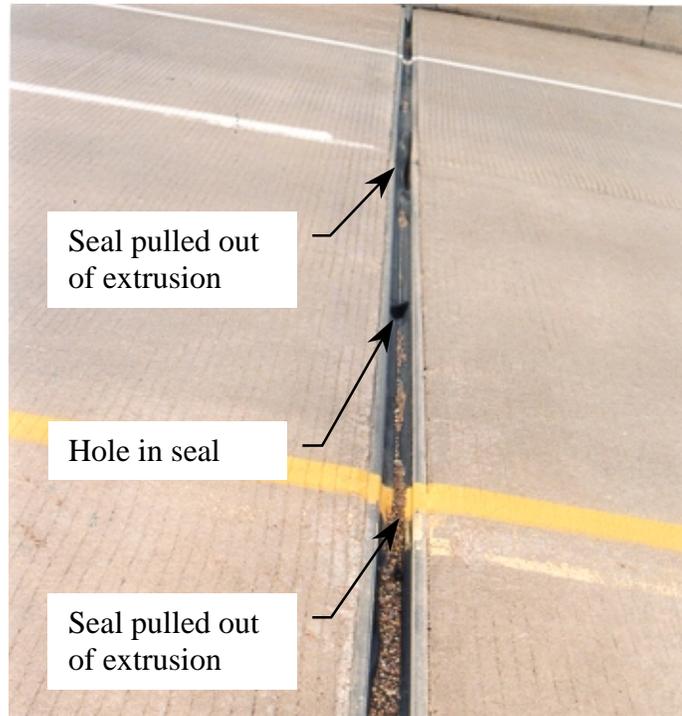
Figure 6.11 Strip seal at G3 for Bridge 3 (0996.0R218)

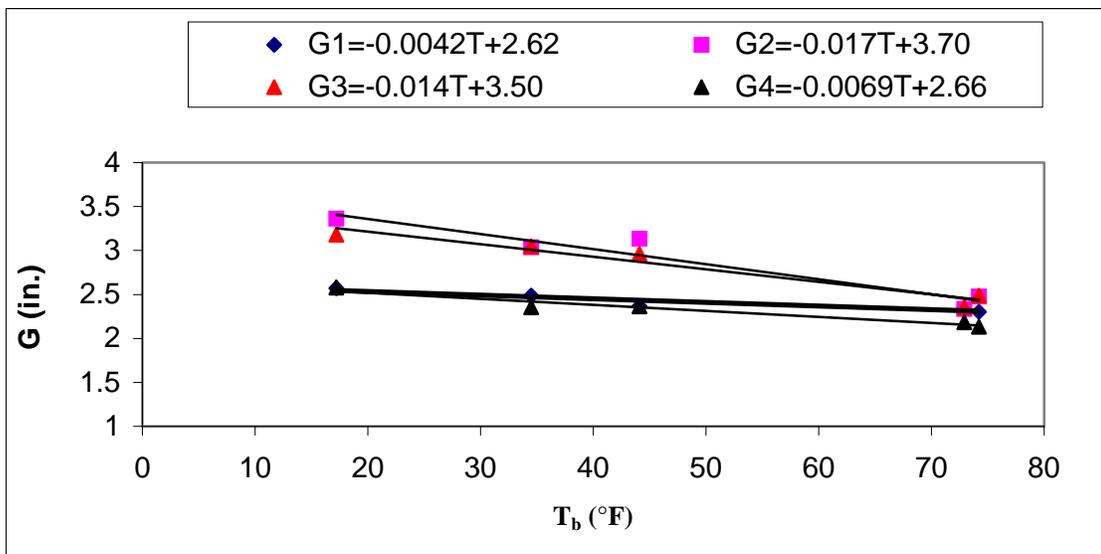
Figure 6.13 Gap openings vs. bridge temperature for Bridge 3 (0996.0R218)

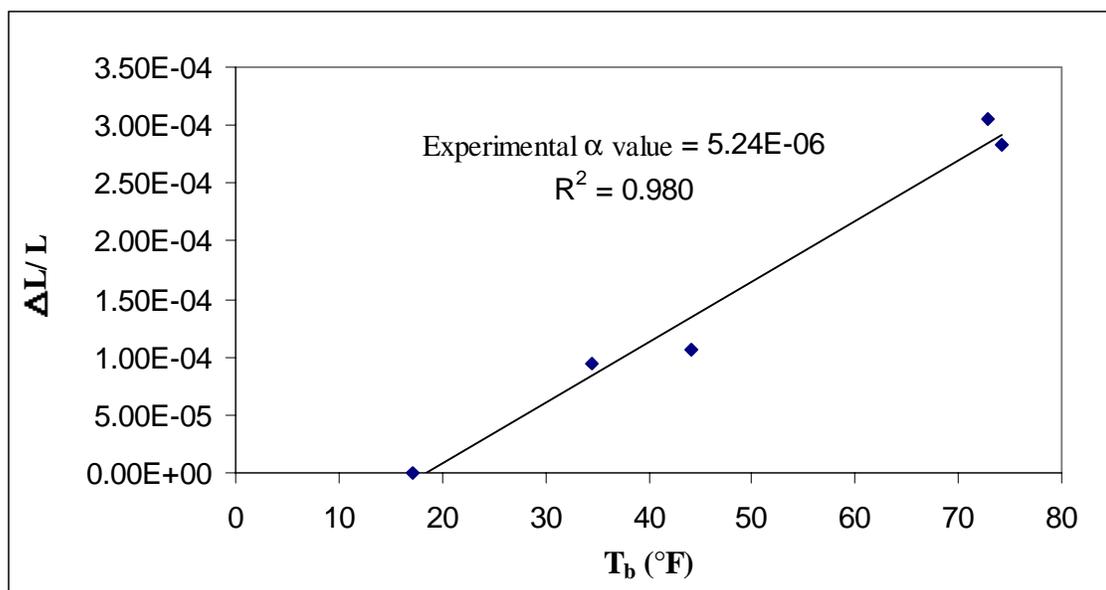
Figure 6.14 The experimental  $\alpha$ -value for Bridge 3 (0996.0R218)

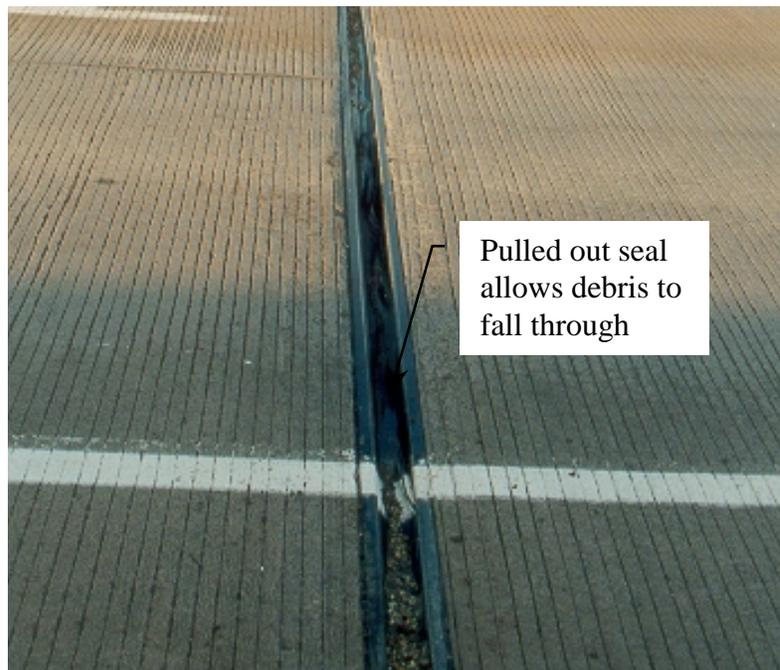
Figure 6.15 Strip seal at G2 for Bridge 4 (0996.0L218)

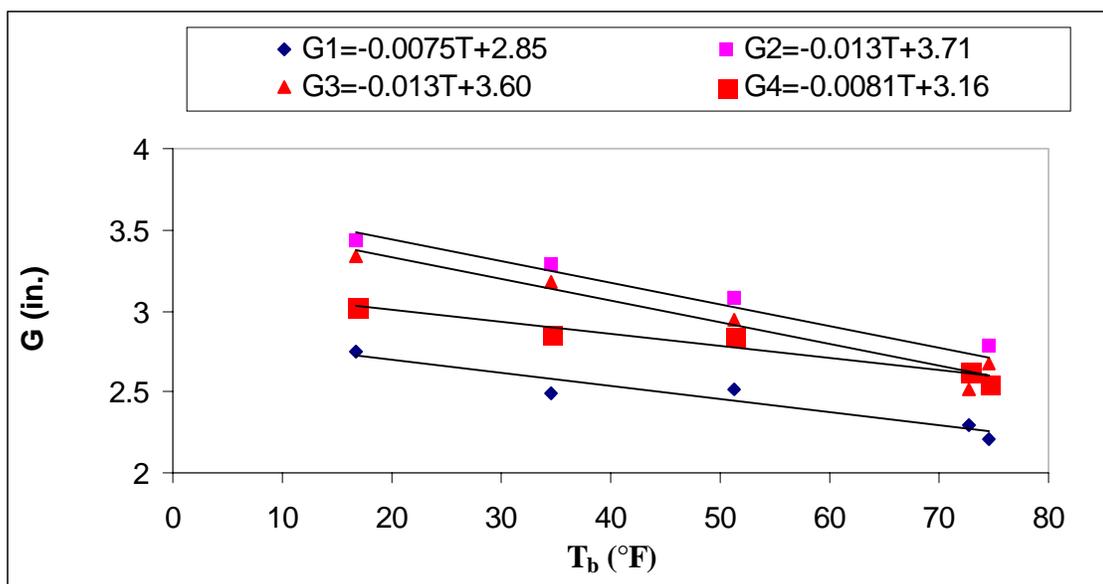
Figure 6.17 Gap openings vs. bridge temperature for Bridge 4 (0996.0L218)

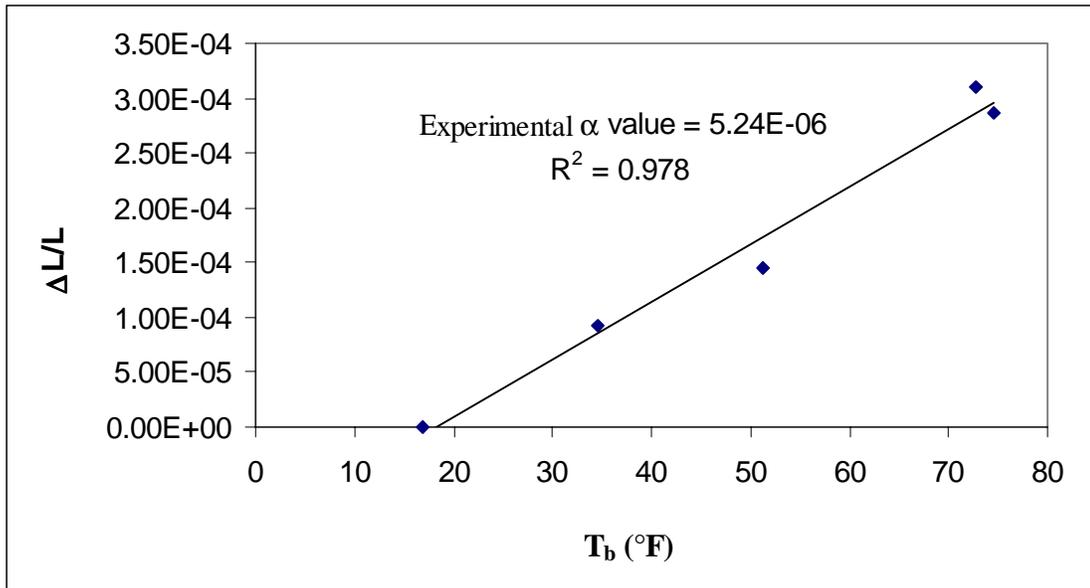
Figure 6.18 The experimental  $\alpha$ -value for Bridge 4 (0996.0L218)At a shade

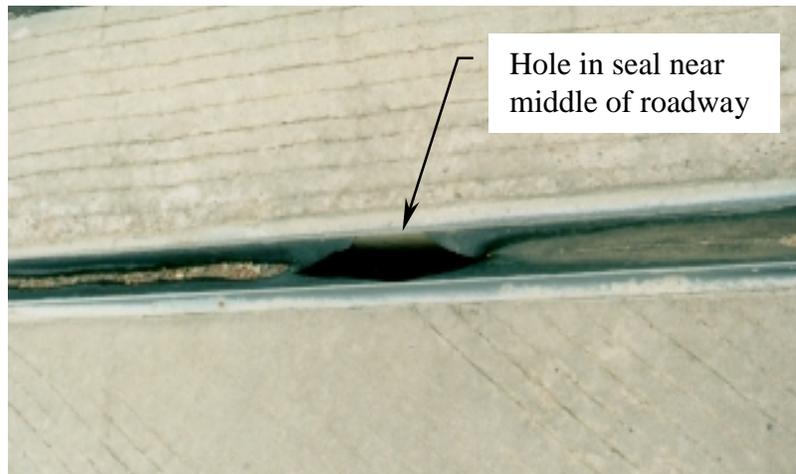
Figure 6.19 Strip seal at G1 for Bridge 5 (0787.7A218)

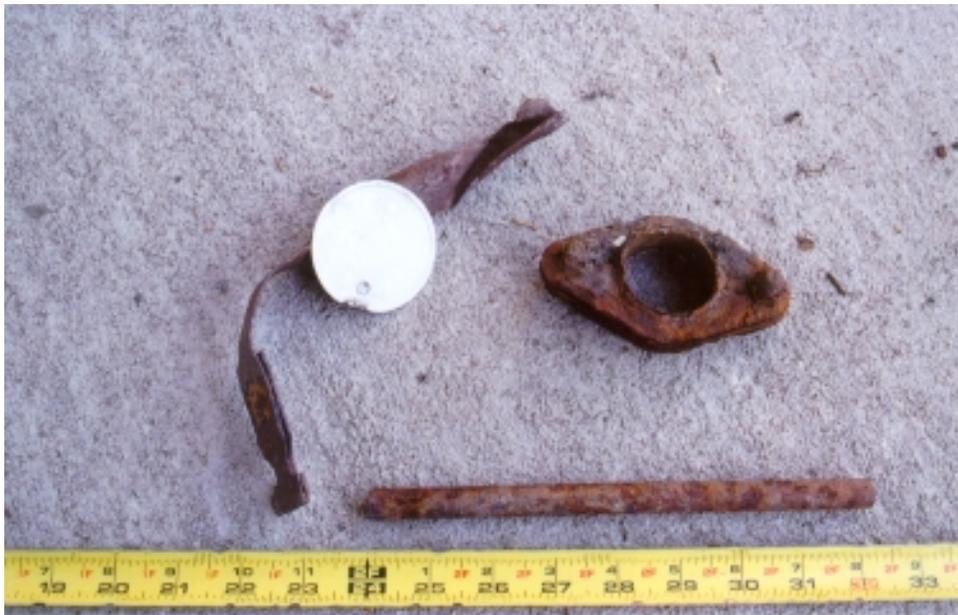
Figure 6.20 Road debris found on Bridge 5 (0787.7A218)

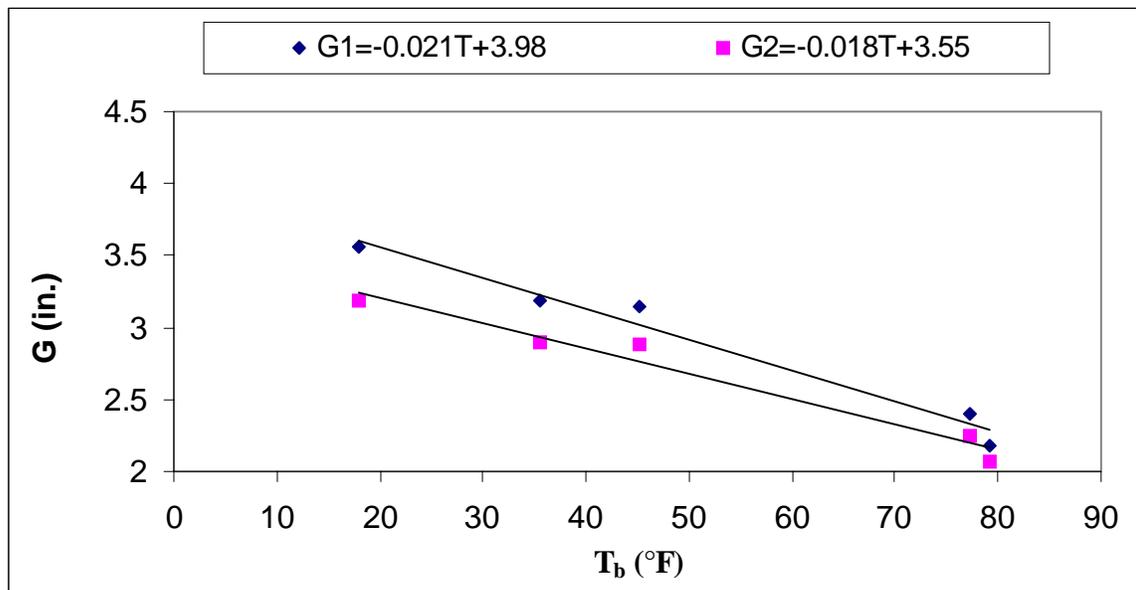
Figure 6.21 Gap opening vs. bridge temperature for Bridge 5 (0787.7A218)

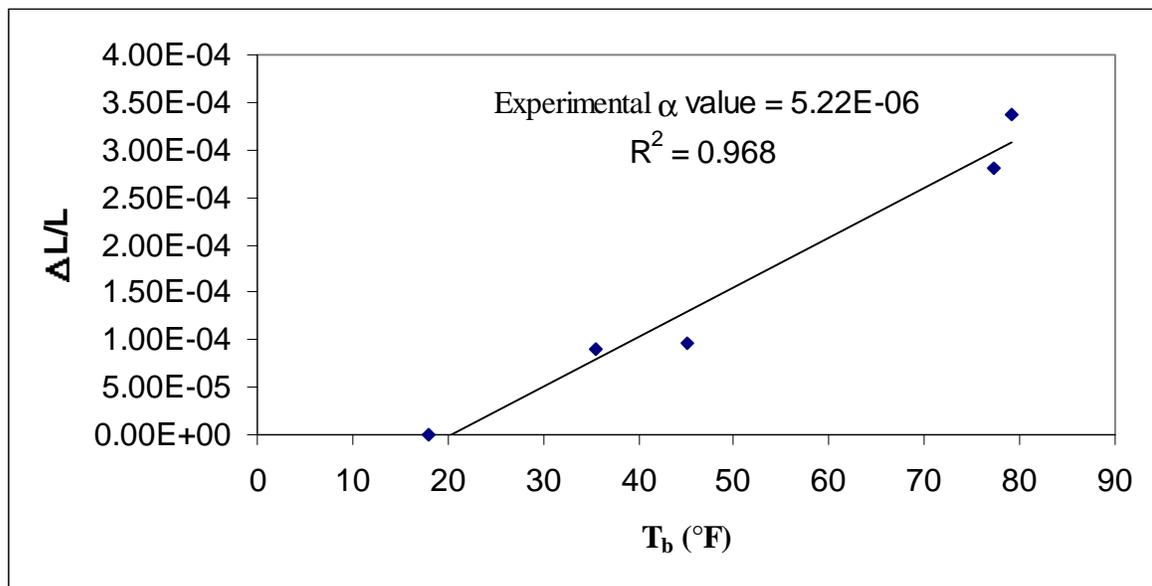
Figure 6.22 The experimental  $\alpha$ -value for Bridge 5 (0787.7A218)

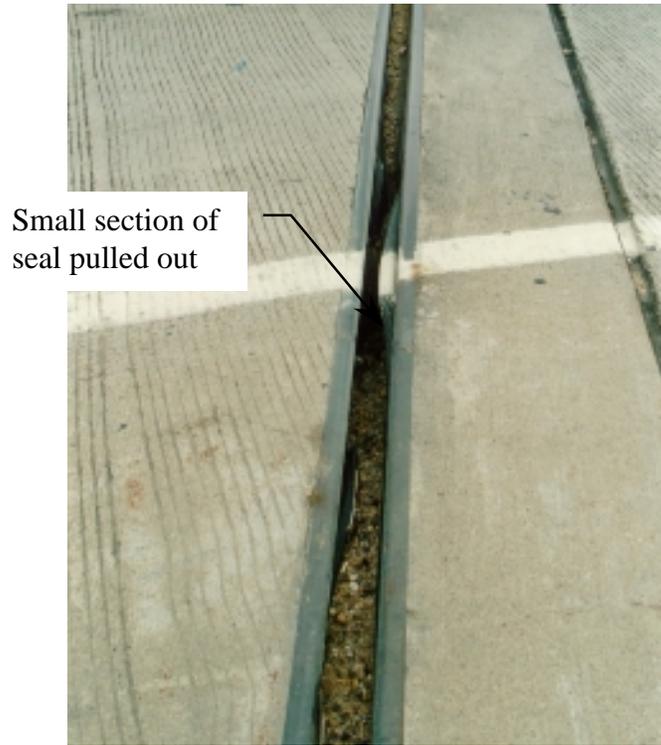
Figure 6.23 Strip seal at G1 of Bridge 6 (0784.8S218)

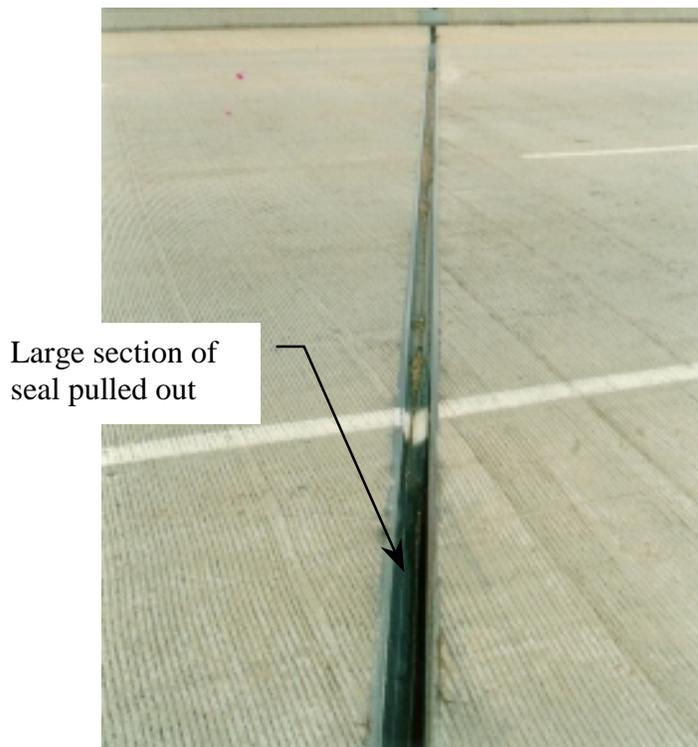
Figure 6.24 Strip seal at G2 of Bridge 6 (0784.8S218)

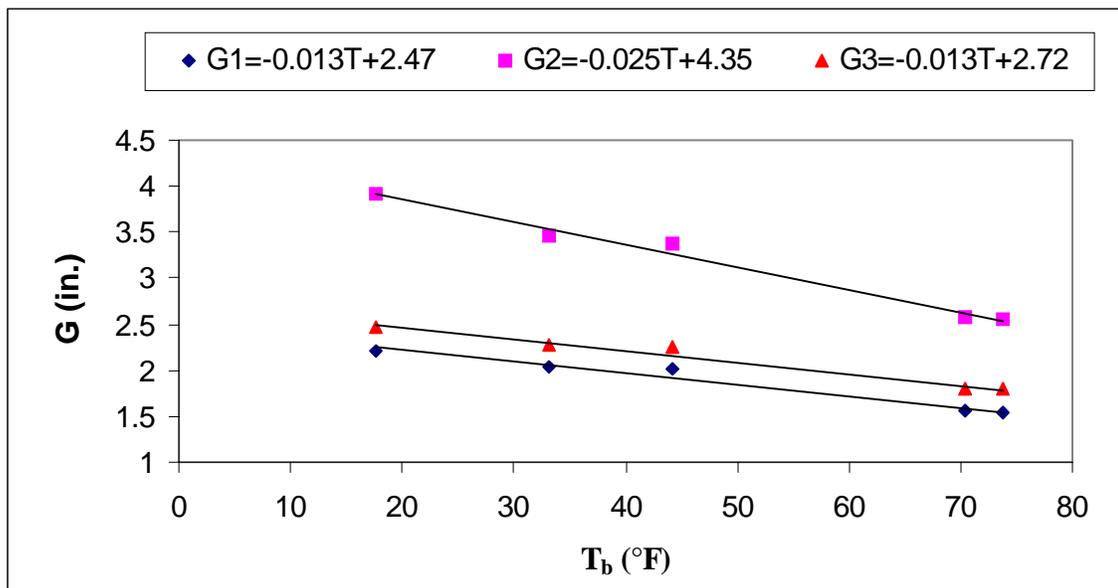
Figure 6.25 Gap openings vs. bridge temperature for Bridge 6 (0784.8S218)

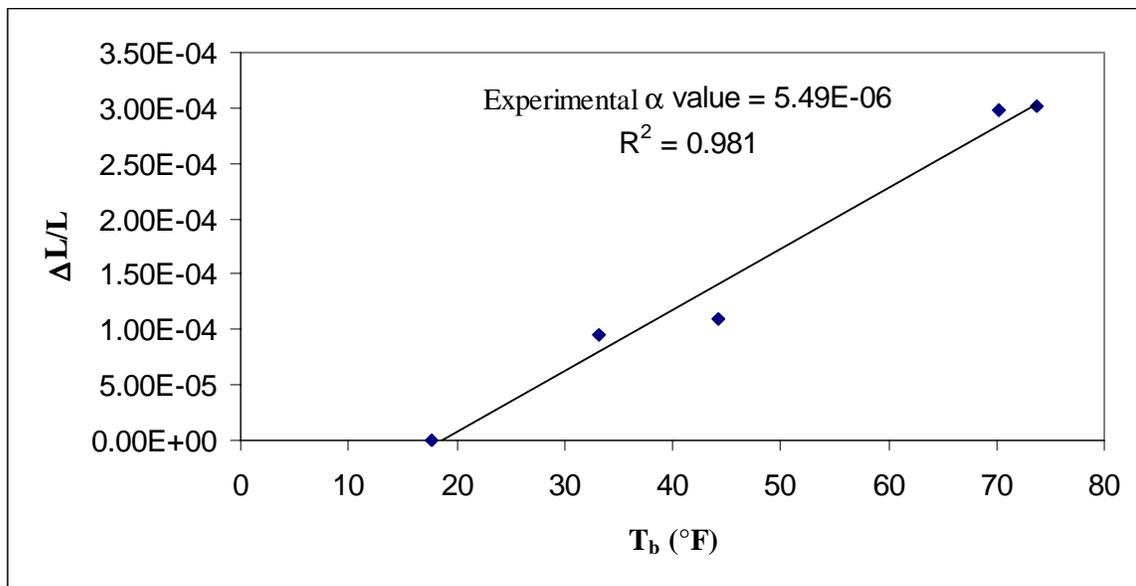
Figure 6.26 The experimental  $\alpha$ -value for Bridge 6 (0784.8S218)

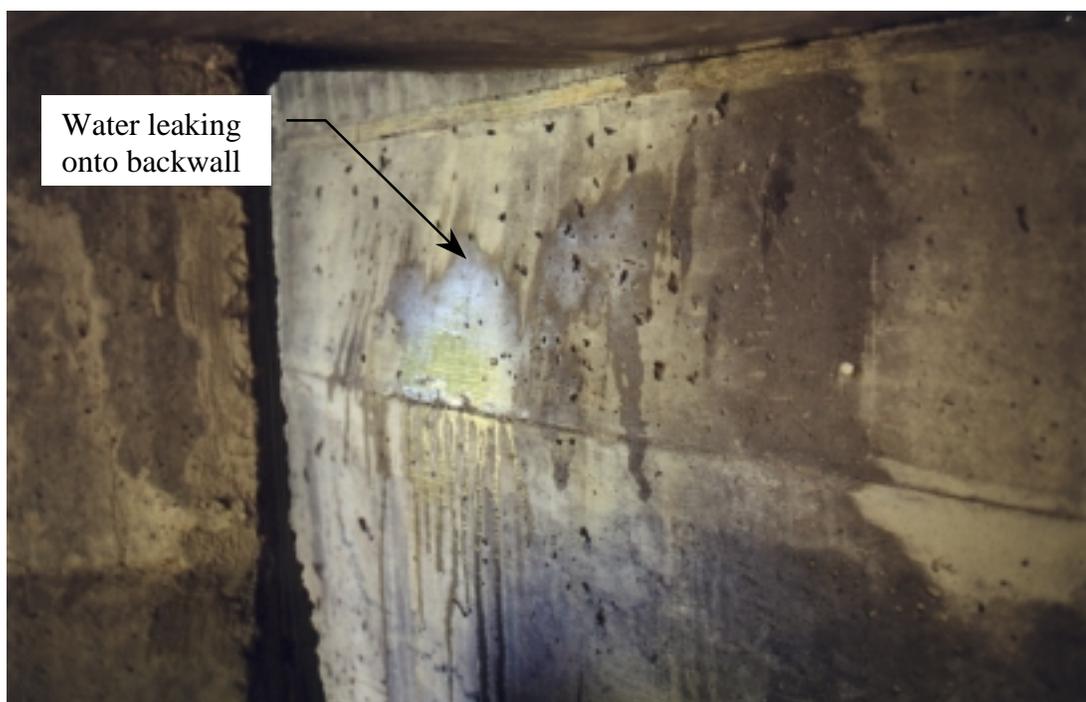
Figure 6.27 Backwall below left gutter at G2 of Bridge 7 (8561.5L030)

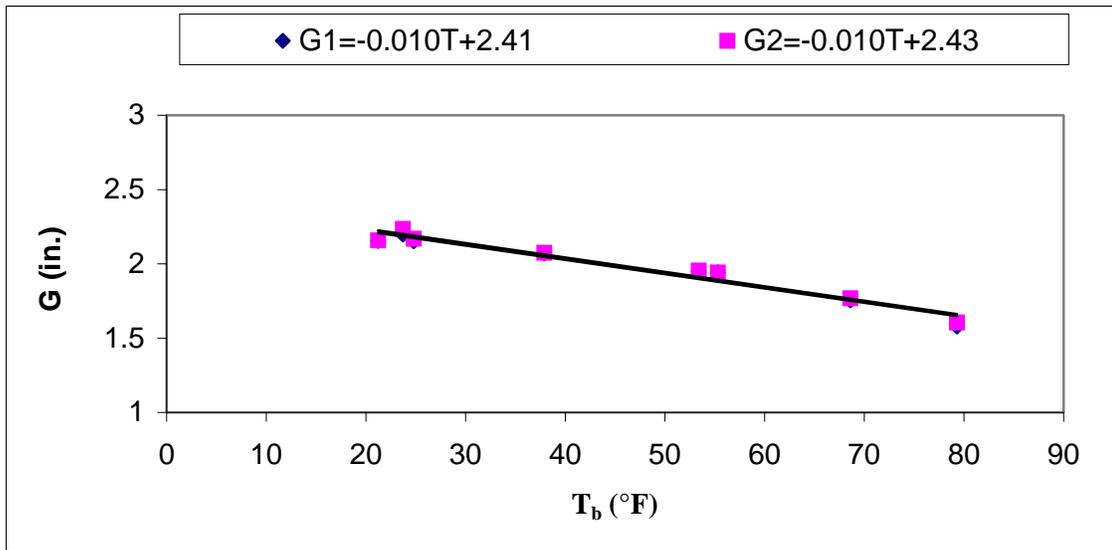
Figure 6.28 Gap opening vs. bridge temperature for Bridge 7 (8561.5L030)

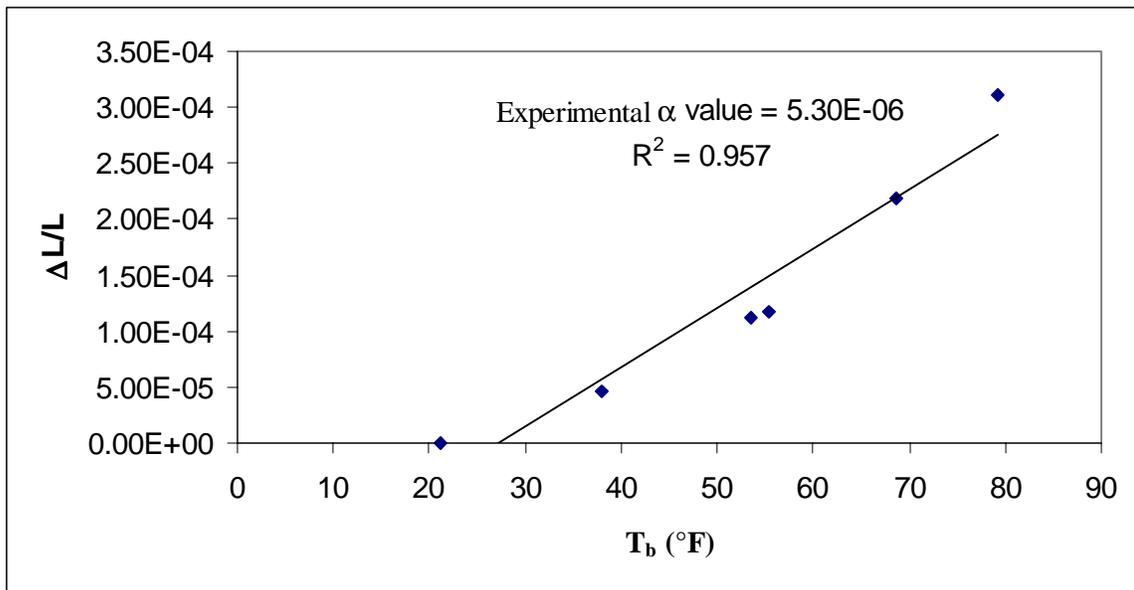
Figure 6.29 The experimental  $\alpha$ -value for Bridge 7 (8561.5L030)

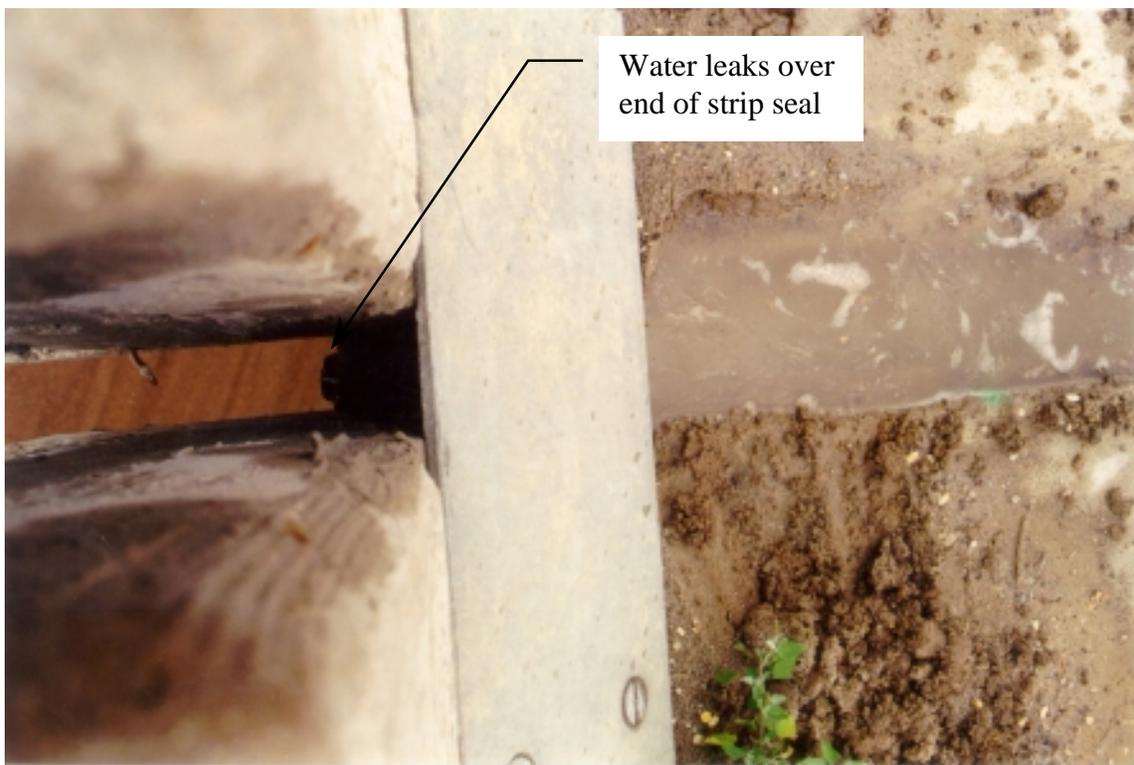
Figure 6.30 Strip seal at G3 for Bridge 8 (7776.8L065)

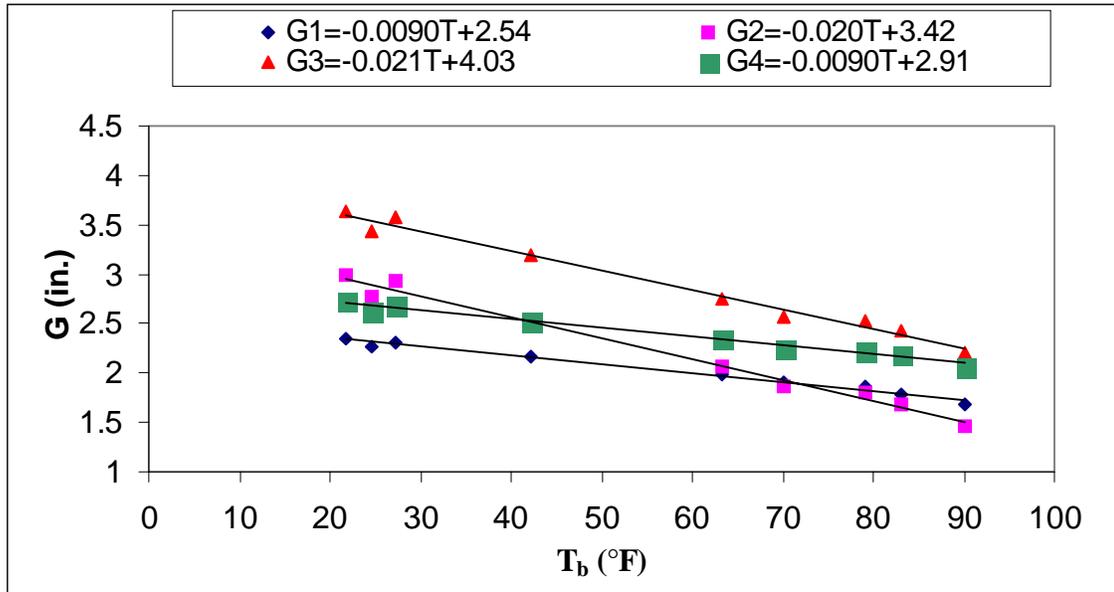
Figure 6.31 Gap opening vs. bridge temperature for Bridge 8 (7776.8L065)

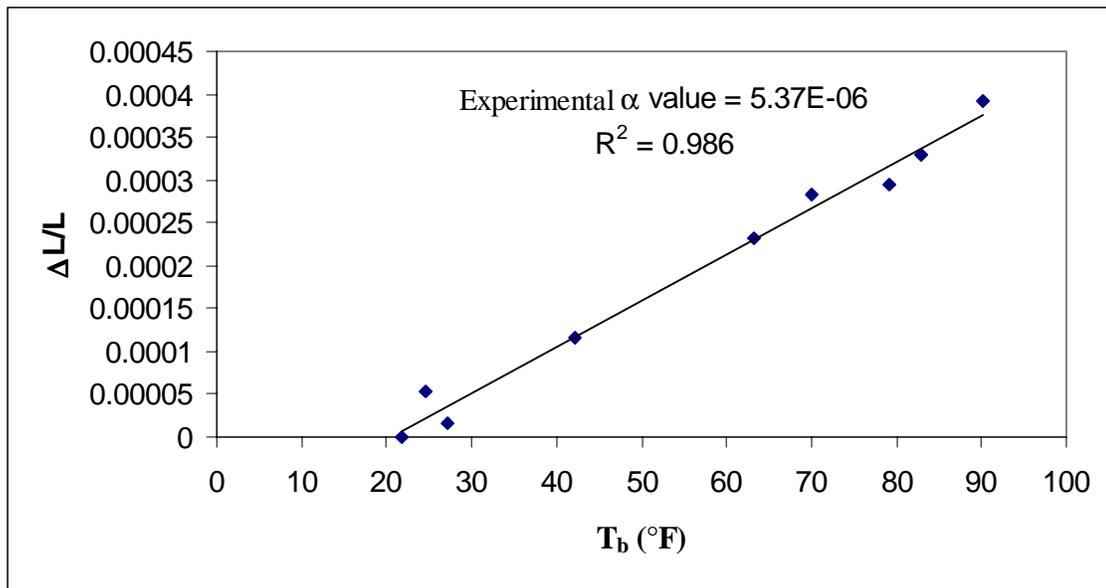
Figure 6.32 The experimental  $\alpha$ -value for Bridge 8 (7776.8L065)
